TENNESSEE STATE DEPT OF CONSERVATION NASHVILLE DIV 0--ETC F/6 13/13
NATIONAL PROGRAM OF INSPECTION OF NON-FEDERAL DAMS, TENNESSEE. --ETC(U)
SEP 81 W E BUSH

REPORT DOCUMENTATION PAGE		READ INSTRUCTIONS BEFORE COMPLETING FORM
1. REPORT NUMBER	2. GOVT ACCESSION NO.	3. RECIPIENT'S CATALOG NUMBER
	AD-A108 239	
4. TITLE (and Subtitle) National Program of Inspection of Non-Federal Dams Tennessee. Nolan Lake Dam (Inventory Number TN 15741) near Memphis, TN, Shelby County, TN, Mississippi River Basin		5. TYPE OF REPORT & PERIOD COVERED Phase 1 Investigation Report

OVERVIEW PHOTO

PHASE I INSPECTION
NOLAN DAM
SHELBY COUNTY, TENNESSEE

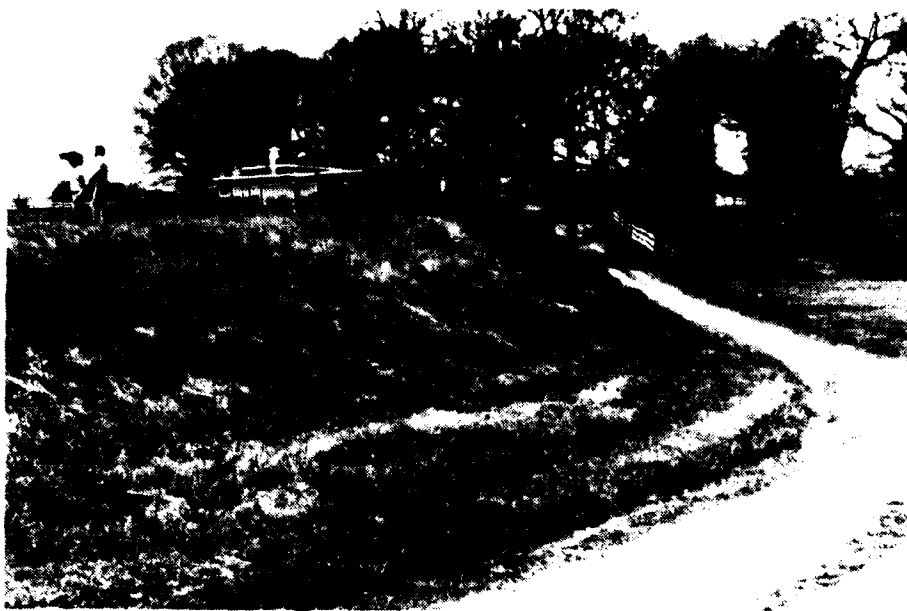
- 3.2.2 Recommendations - The owner should keep the wet area on the backslope of the dam under close observation for changes in area and flow until remedial work is begun. Consideration should be given to methods and length of time required to draw down the impoundment. A qualified engineer should be retained to:

1. Backslope - Nolan Dam. Seep located generally within area bounded by high weeds.

- a. Recommend measures to the owner for the removal and replacement of the upstream slope protection.
 - b. Determine the cause of seepage in the downstream slope and propose remedial measures.

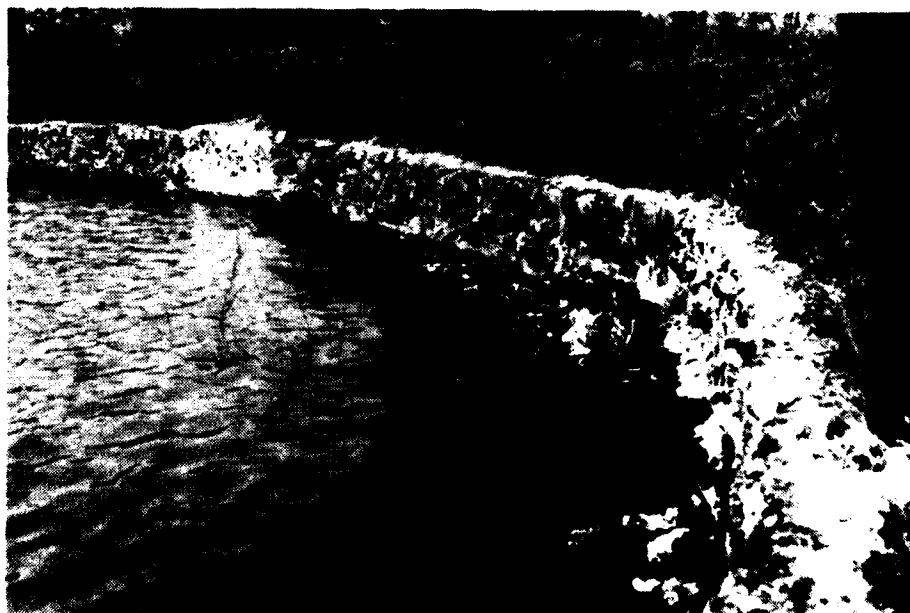
- b. On the basis of engineering judgment and visual observations, the upstream slope appears unstable due to wave action undermining the broken concrete masonry wall and subsequent movement of soil immediately behind the wall.

2. Upstream slope - Nolan Dam. Note masonry wall and patched areas. Also undercutting of foundation.

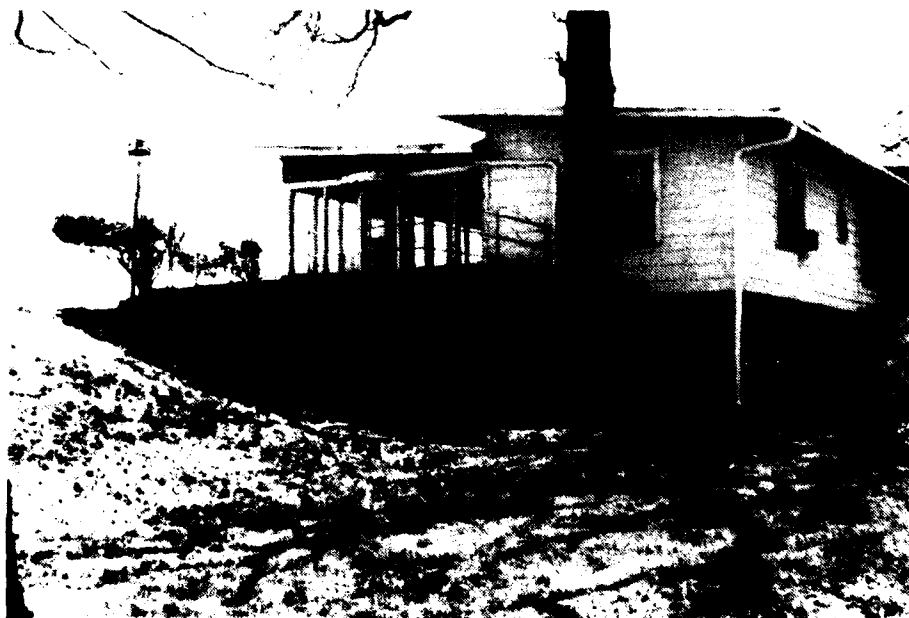
4. House with foundation and lower floor built into downstream slope of Nolan Dam.

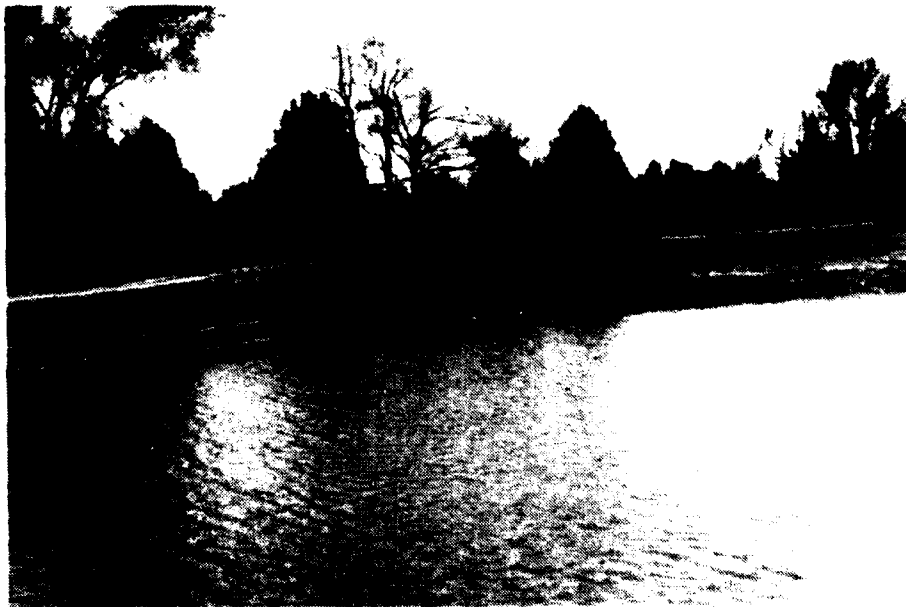
The emergency spillway is located in the east abutment. This spillway is a rectangular spillway with both sides of the entrance channel protected by broken concrete masonry walls. The bottom appears to be earth. No control section was noted. A farm road crosses the emergency spillway approximately 50 feet from the entrance and the fill contains four 18 inch corrugated metal pipes. These pipes act as a control for the emergency spillway. The pipes were partially obstructed by dirt, weeds, and other debris and are subject to complete stoppage by debris build up. Both the upstream and downstream ends of the pipe are protected by a concrete headwall. The outfall ditch below the roadway is grown up with small trees, tall grass, and other vines.

6. Entrance to emergency spillway in right abutment - Nolan Dam.

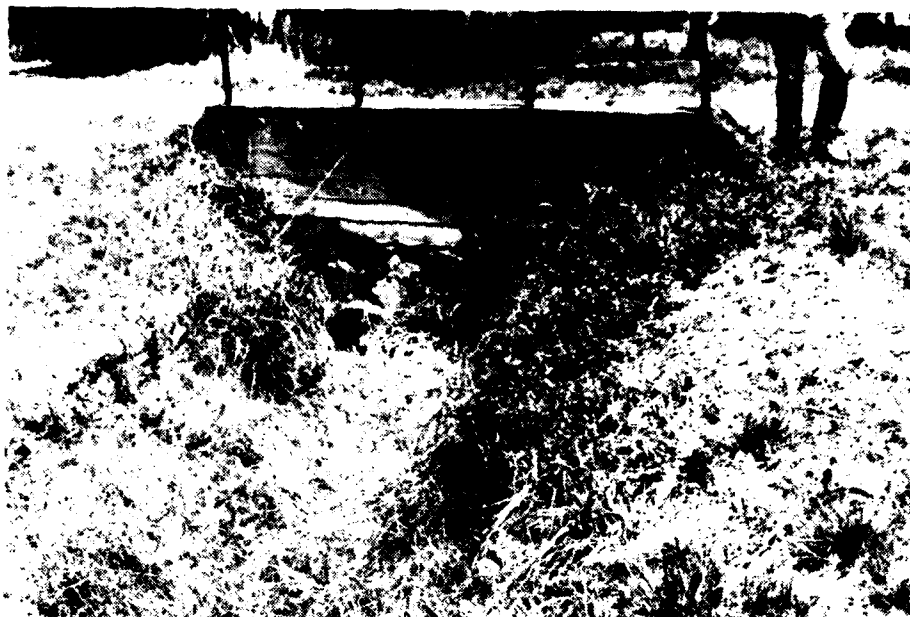
7. Four 18 inch CM pipes under farm road that controls discharge through emergency spillway - Nolan Dam.

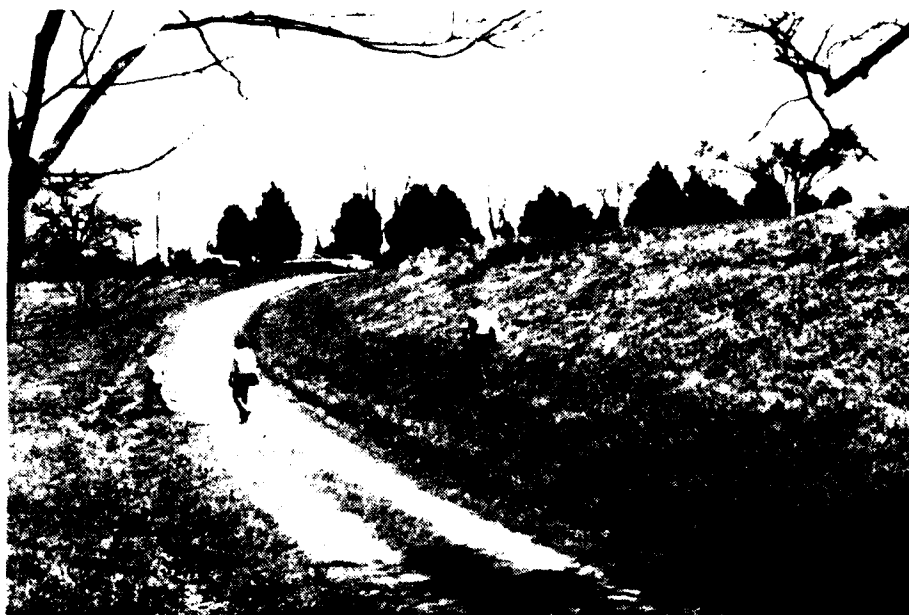
9. Backslope - Nolan Dam. Wet area in high weeds at center photograph. Drawdown pipe outlet of left side of picture where man is standing.
